INSPECTION REPORT

For the Property at:
EXAMPLE REPORT
MY VILLAGE, NJ

Prepared for: WILLIAM VANTASSEL
Inspection Date: Wednesday, April 7, 2021
Prepared by: William Vantassel, 24GI00210600

RE: Report No. 1036, v.0
Example Report
My Village, NJ

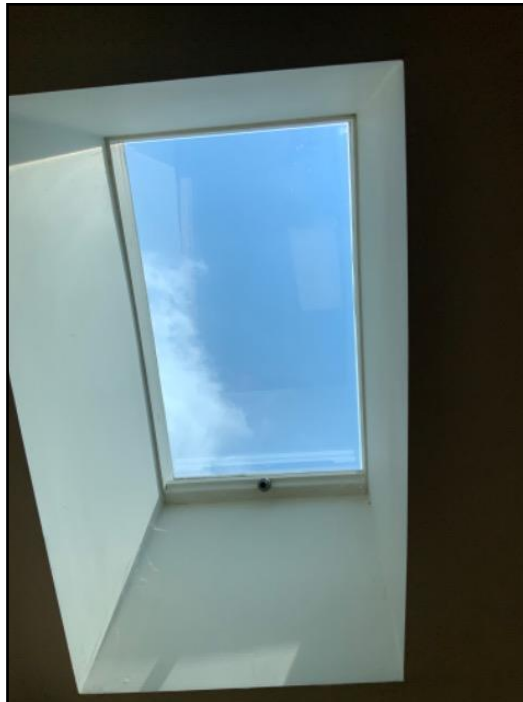
Condition: • Skylights are known to be problematic and a weak point in a roofing system . No leaks were found at the time of inspection. Recommend close monitoring as part of regular home maintenance.

Skylights are known to be problematic and a...

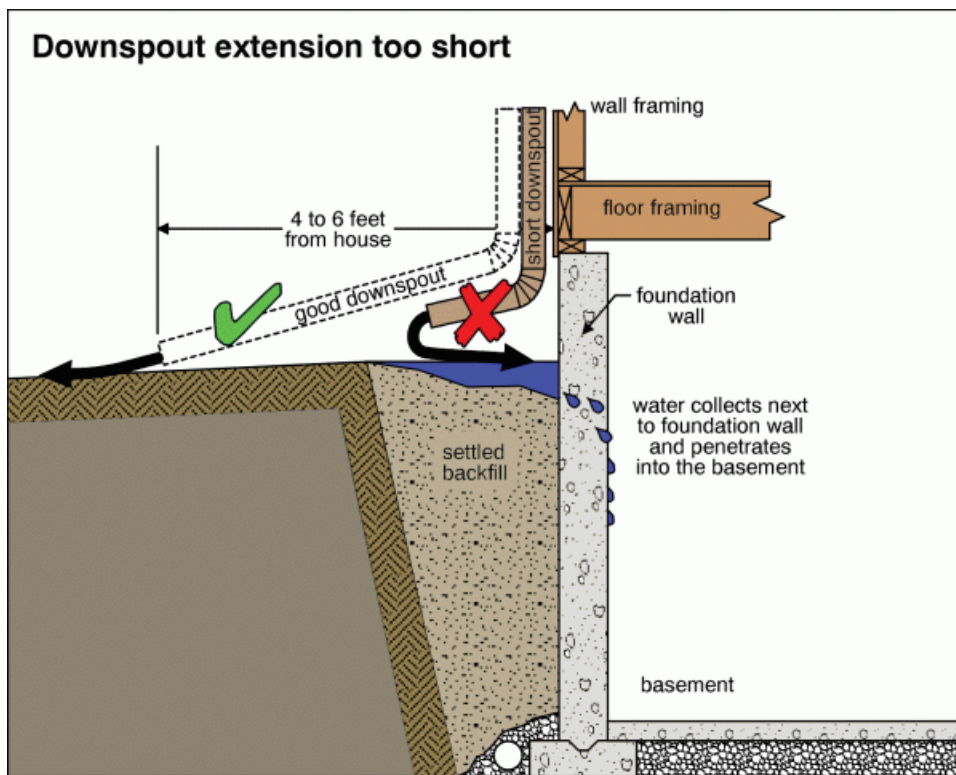
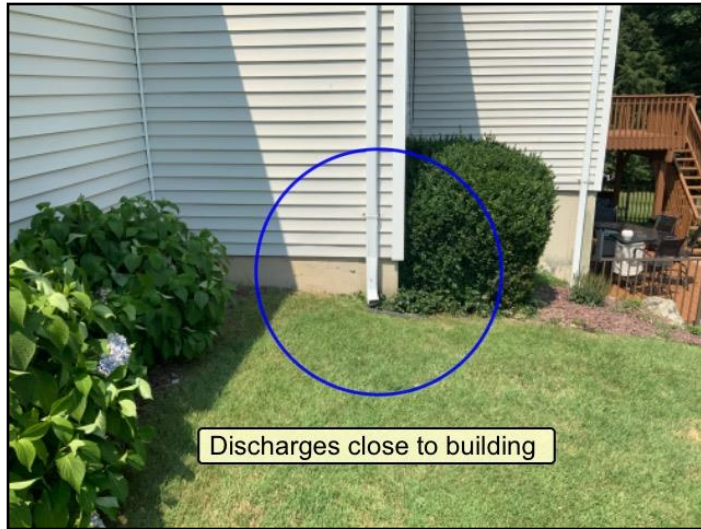
Several gutters and downspouts around the home discharge too close to the foundation of the home. Each downspout is recommended to discharge at a minimum of 4 to 6 feet away from the foundation. Recommendation is to have this condition repaired by a properly licensed contractor.

Implication(s): Chance of water damage to structure, finishes and contents

Discharge too close to building

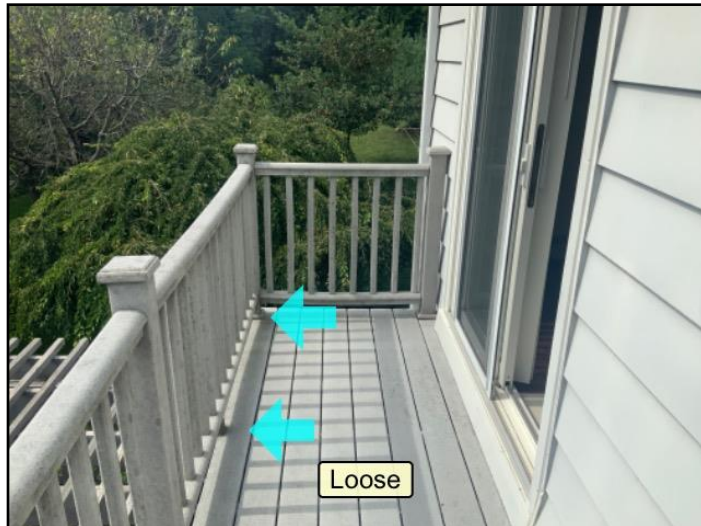
The railing on the second floor deck is extremely loose. This is a safety concern and should be repaired immediately by a properly licensed contractor .

Implication(s): Fall hazard

Loose

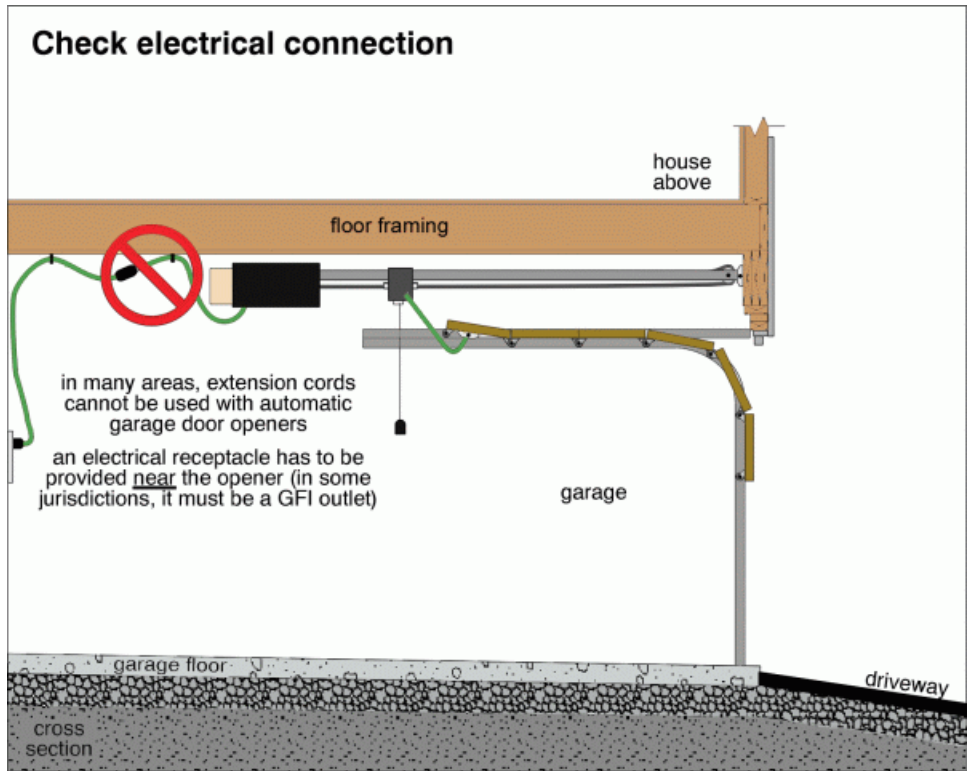
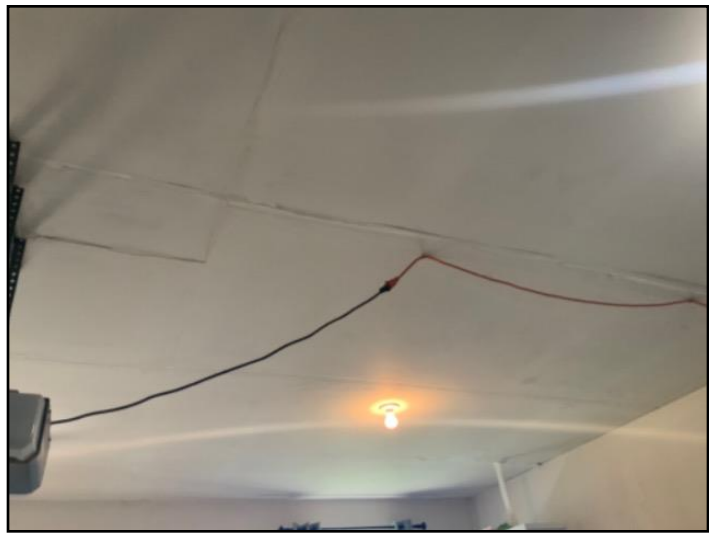
An extension cord is being used to power the garage door opener. The recommendation is to have an independent GFCI outlet installed for the garage door opener by a property license electrician.

Implication(s): Electric shock

Extension cord for opener

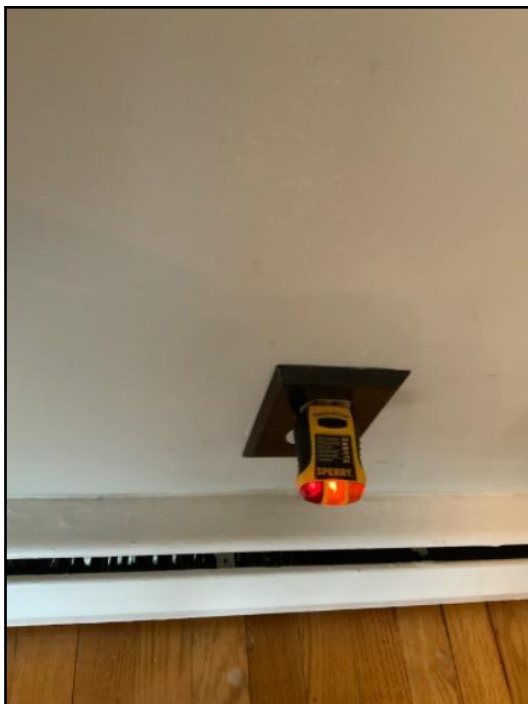
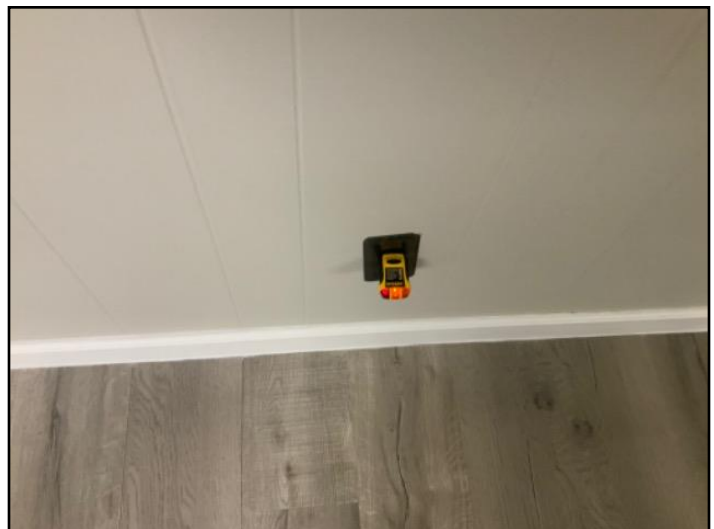
Various electrical receptacles in the home had hot and neutral wires reversed.(Reversed Polarity) This condition should be corrected by a qualified electrical contractor and all receptacles further evaluated . Note only a representative of receptacles were tested during the home inspection It is likely other receptacles have the same problem.

Implication(s): Electric shock

Reversed polarity

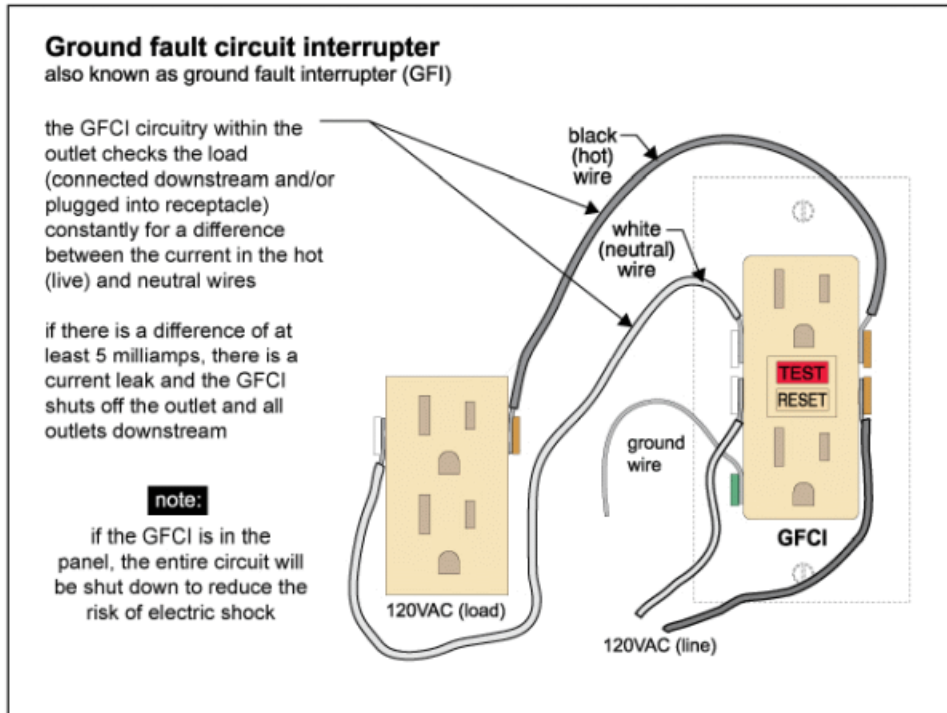
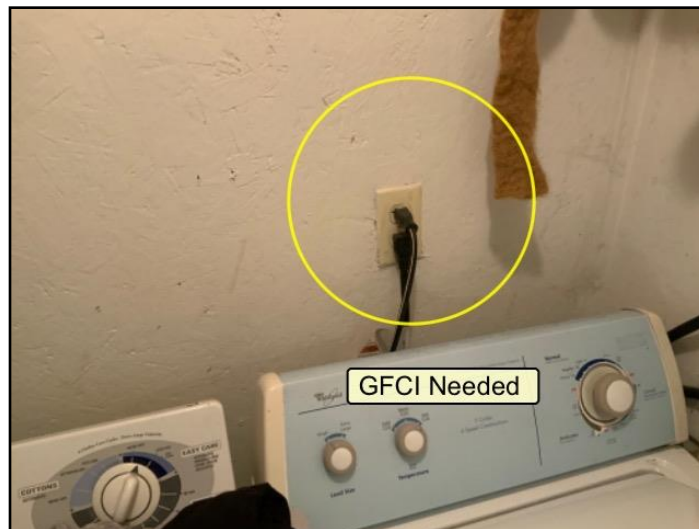
Outlet above washing machine should be GFCI protected. Recommendation is to have a license electrician install a new GFCI outlet.

Implication(s): Electric shock

GFCI/GFI needed (Ground Fault Circuit...)

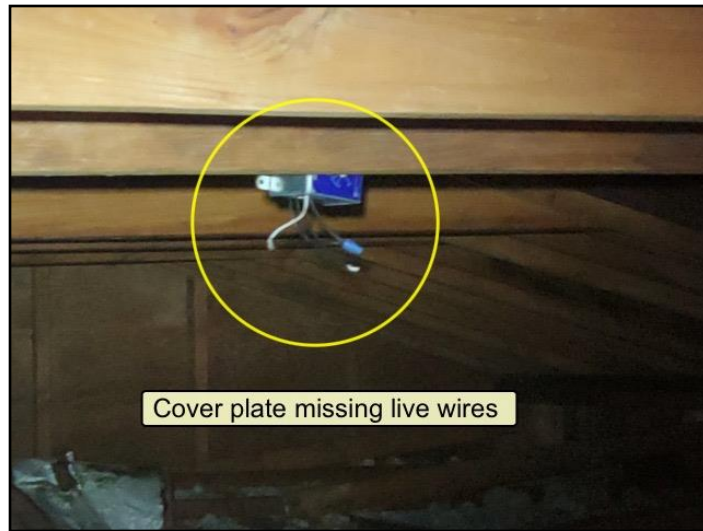
Cover plate is missing on a junction box in attic and the exposed wires are live. Recommendation is to have this condition repaired by a properly licensed electrician this is a safety hazard and should be repaired immediately.

Implication(s): Electric shock

For junction box is missing

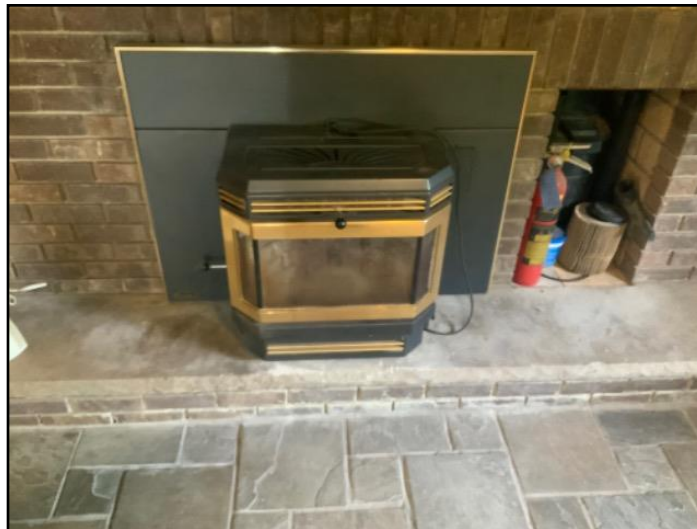
Condition: • [We are not certified chimney professionals. Only a level two inspection performed by a CSIA \(Chimney Safety Institute of America\) certified chimney sweep can determine the condition of the flue and wheather the fireplace is safe to use.](#)

We are not certified chimney professionals....

We recommend a cleaning and level two inspection of the fireplaces and chimney flues before closing or use. Clean chimneys don't catch on fire. More information about fireplaces and chimneys can be obtained at www.csia.com.

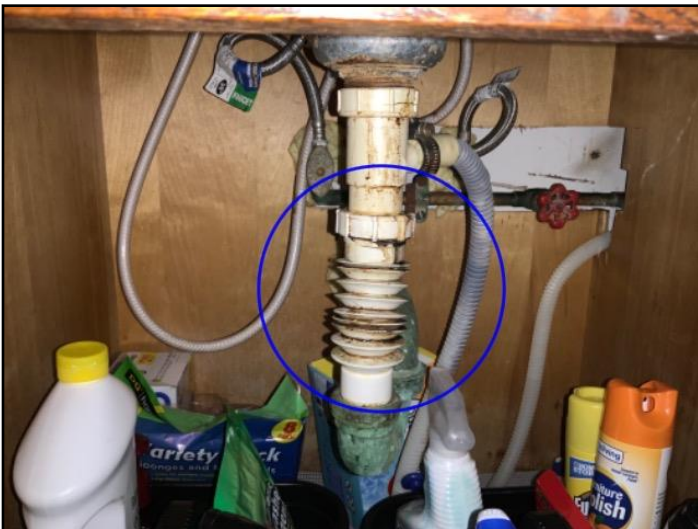
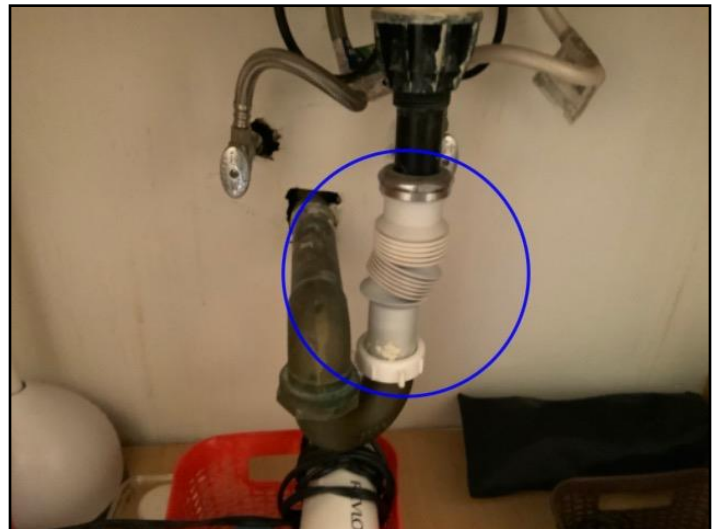
Nonstandard materials used for drain pipe underneath both bathroom sinks. It is recommended to have this repaired by a properly licensed plumber.

Implication(s): Chance of water damage to structure, finishes and contents | Sewage entering the building

Nonstandard materials and patches

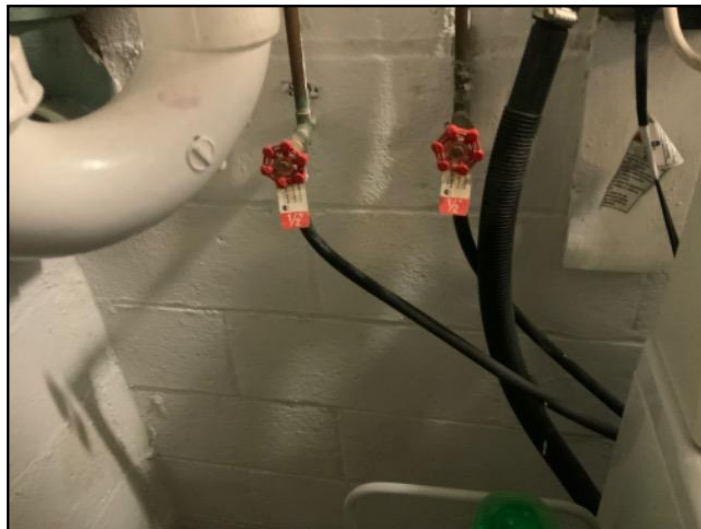
Rubber hoses are used for water service lines connecting to the washing machine. It is recommended that these lines be replaced with stainless steel braided lines as these lines are much stronger and less likely to burst.

Implication(s): Chance of water damage to structure, finishes and contents

Old/Low quality hoses

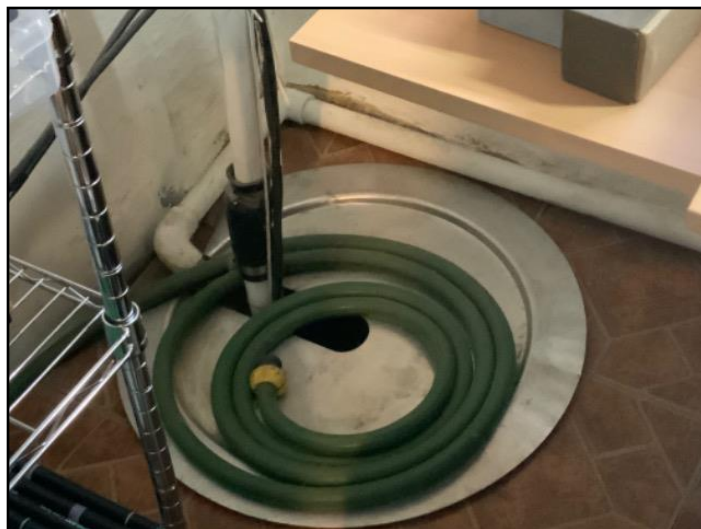
- Sump pumps should be tested regularly and have a battery back up in the event of a power failure.

sump pumps should be tested regularly and...

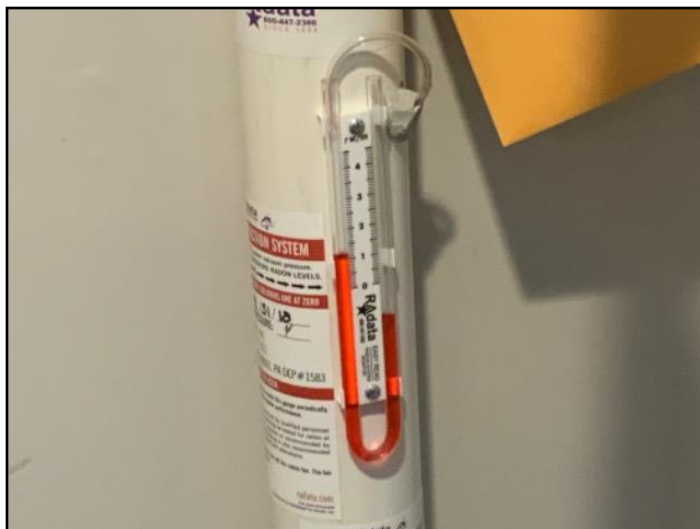
Condition: • Radon mitigation system noted in lower level of home. This system should only be serviced by a professional there is a phone number printed on the equipment for questions or concerns.
