INSPECTION REPORT

For the Property at:
EXAMPLE REPORT
MY VILLAGE, NJ

Prepared for: WILLIAM VANTASSEL
Inspection Date: Wednesday, April 7, 2021
Prepared by: William Vantassel, 24GI00210600

RE: Report No. 1036, v.0
Example Report
My Village, NJ

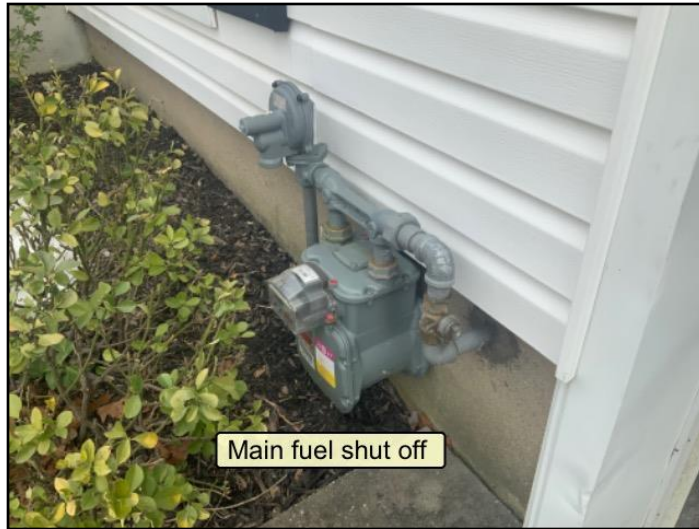
Main fuel shut off

Exterior wall

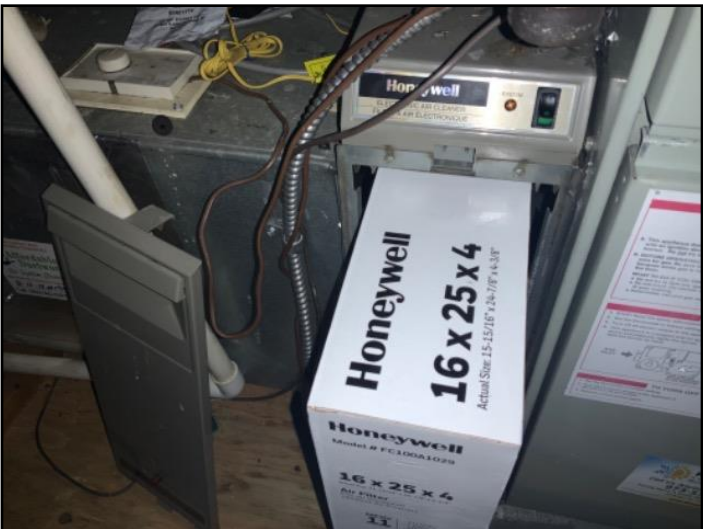
Air filter: • Disposable
Air filter: • Disposable air filter located in attic this should be checked and replaced as needed as part of regular maintenance.
Size is 16x25x4
